TOSHIBA's MSV Bypass Valve Upgrade offers a unique main stop valve bypass configuration that addresses commonly experienced solid particle erosion (SPE) issues. It's the answer to time and resource-consuming inspections and maintenance of conventional design bypass valves. The multi-hole MSV bypass valve greatly reduces O&M costs, while increasing steam turbine availability. The design dramatically extends bypass valve service life and requires only minor modifications to install.

Proven Toshiba-patented Technology

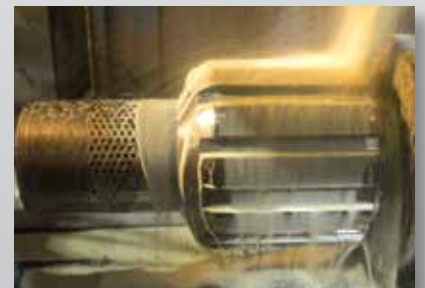
| ① Bypass valve | ④ Valve stem |
| ② Bypass valve cap | ⑤ Pressure seal head |
| ③ Main valve disc | ⑥ Bushings |

TOSHIBA's improved design redirects the steam path to prevent solid-surface impact, thereby eliminating erosion problems. Stellite coatings in high-wear areas, as well as upgraded valve stem and bushing materials, also ensure worry-free performance.
